**NJ64 HZP, NISSAN LEAF**

Appraised: 11/06/2021

Odometer: 55,005 miles

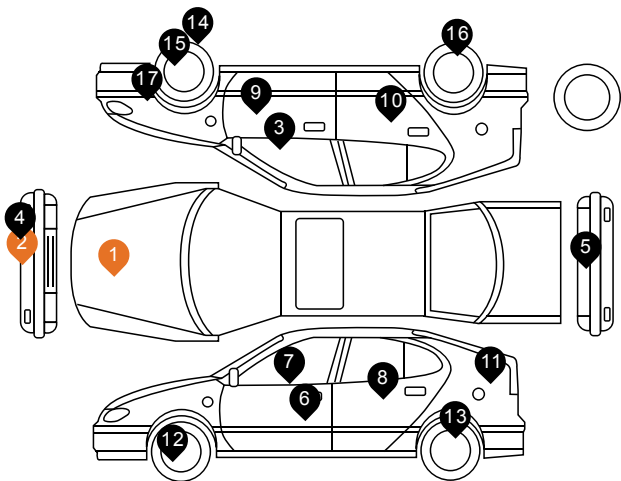
**Exterior condition**

- 1 Bonnet; Chipped; Multiple Chips

- 2 Bumper Front; Scratched; Over 100mm Thru Paint

- 3 A Post os; Scratched; UpTo 25mm Thru Paint

- 4 Bumper Front; Chipped; Multiple Chips

- 5 Bumper Rear; Scratched; 25 to 100mm Thru Paint

- 6 Door nsf; Scratched; UpTo 25mm Thru Paint

- 7 Door nsf; Chipped; Edge Chip

- 8 Door nsr; Chipped; Edge Chip

- 9 Door osf; Chipped; Edge Chip

- 10 Door osr; Chipped; Edge Chip

- 11 Qtr Panel nsr; Dented; Between 10mm + 30mm

- 12 Wheel nsf; Corroded; Light

- 13 Wheel nsr; Scratched; Over 50mm

- 14 Wheel osf; Scratched; Over 50mm

- 15 Wheel osf; Corroded; Light

- 16 Wheel osr; Corroded; Light

- 17 Wing osf; Chipped; 1 To 5

18 Bonnet; Scratched; Over 25mm Not Thru Paint

19 C Post ns; Scratched; Over 25mm Not Thru Paint

20 Door nsf; Scratched; Over 25mm Not Thru Paint

21 Door nsr; Scratched; Over 25mm Not Thru Paint

22 Door osf; Scratched; Over 25mm Not Thru Paint

23 Door osr; Scratched; Over 25mm Not Thru Paint

24 Roof; Scratched; Over 25mm Not Thru Paint

25 Tailgate; Scratched; Over 25mm Not Thru Paint

26 Wing nsf; Scratched; Over 25mm Not Thru Paint

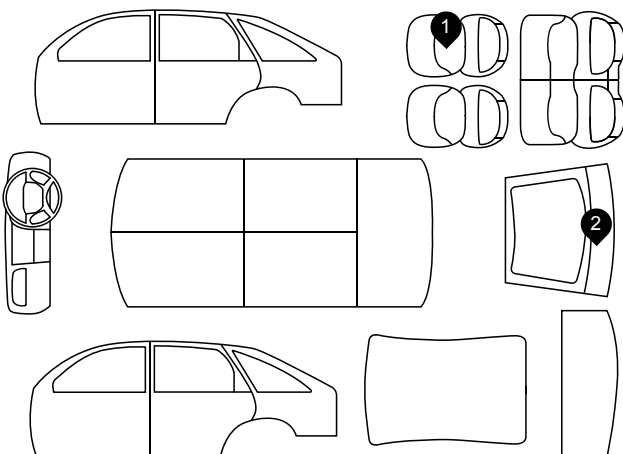
## Interior condition

1 Seat Back Cover osf; Scuffed; Over 25mm

2 Tailgate Pad; Scuffed; Over 25mm

3 Door Pad osf; Soiled; Light

4 Door Pad osr; Soiled; Light

5 Rear Panel Trim Int; Soiled; Light

6 Seat Back Cover nsr; Soiled; Light

7 Seat Base Cover nsr; Soiled; Light
